# WOOD DESTROYING PESTS AND ORGANISMS INSPECTION REPORT

Building No. <b>1313</b>	Street <b>Park Pleasant Circle</b>	City <b>San Jose</b>	Zip <b>95127</b>	Date of Inspection <b>06/17/08</b>	Page <b>1 of 10</b>
-----------------------------	---------------------------------------	-------------------------	---------------------	---------------------------------------	------------------------

General Description: <b>One story, single family, stucco and wood siding, composition roof, crawl space, attached garage, vacant</b>	Inspection Tag Posted: <b>Garage</b>
	Other Tags Posted:

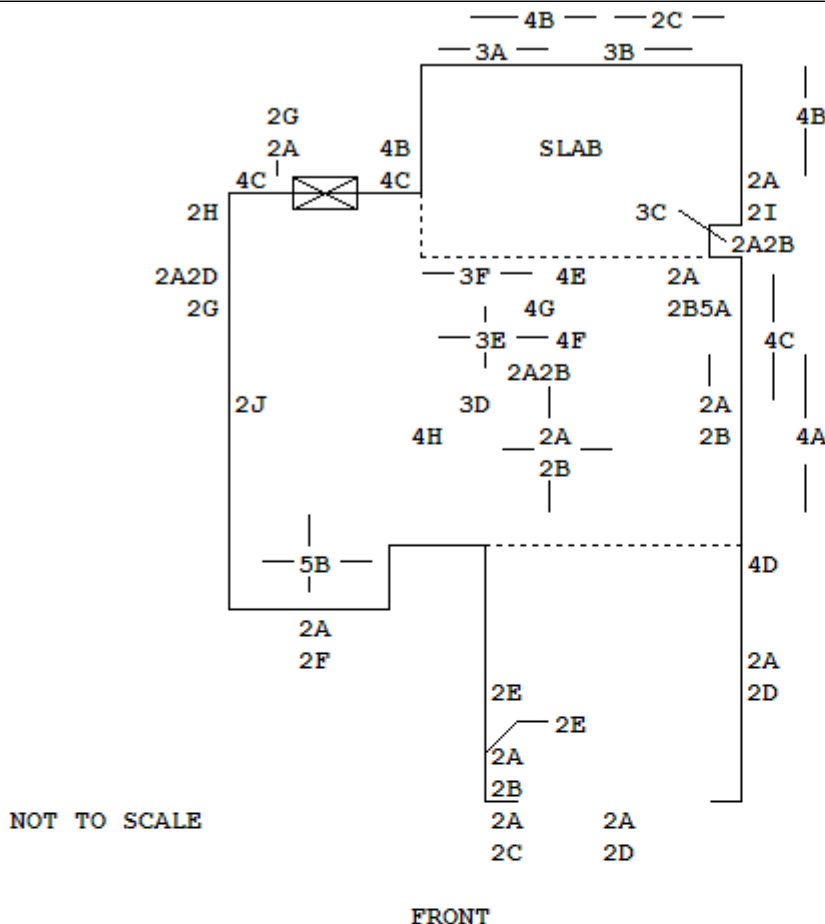
2A. FINDING: Evidence of drywood termites was observed at the areas noted as 2A on the diagram.

2B. FINDING: Evidence of drywood termites, in the form of drywood PELLETS, was observed, noted as 2B on the diagram.

2C. FINDING: Drywood termite damage was observed at the siding, noted as 2C on the diagram.

2D. FINDING: Drywood termite damage was observed at the rafter tail, noted as 2D on the diagram.

2E. FINDING: Drywood termite damage was observed at the studs, noted as 2E on the diagram.

2F. FINDING: Drywood termite damage was observed at the fascia, noted as 2F on the diagram.

2G. FINDING: Drywood termite damage was observed at the eaves, noted as 2G on the diagram.

2H. FINDING: Drywood termite damage was observed at the barge rafter, noted as 2H on the diagram.  
RECOMMENDATION: REMOVE and REPLACE the damaged wood members. If possible, we will chisel or cut out damaged area and fill with either a plastic or wood filler. We will then sand and primer paint. SECTION I ITEM.

2I. FINDING: Drywood termite damage was observed at the side door trim, noted as 2I on the diagram.  
RECOMMENDATION: REMOVE and REPLACE the damaged wood members. If possible, we will chisel or cut out damaged area and fill with either a plastic or wood filler. We will then sand and primer paint. SECTION I ITEM.

2J. FINDING: Drywood termite damage was observed at the window stool, noted as 2J on the diagram.  
RECOMMENDATION: REMOVE and REPLACE the damaged wood members. If possible, we will chisel or cut out damaged area and fill with either a plastic or wood filler. We will then sand and primer paint. SECTION I ITEM.

2K. FINDING: Drywood termite damage was observed at the subfloor, noted as 2K on the diagram.  
RECOMMENDATION: REMOVE and REPLACE the damaged wood members. SECTION I ITEM.

3A. FINDING: Fungus damage was observed at the rafter tail (3x), noted as 3A on the diagram.  
RECOMMENDATION: REMOVE and REPLACE the damaged wood members. If possible, we will chisel or cut out damaged area and fill with either a plastic or wood filler. We will then sand and primer paint. SECTION I ITEM.

3B. FINDING: Fungus damage was observed at the siding, noted as 3B on the diagram.  
RECOMMENDATION: REMOVE and REPLACE the damaged wood members. If possible, we will chisel or cut out damaged area and fill with either a plastic or wood filler. We will then sand and primer paint. SECTION I ITEM.

3C. FINDING: Fungus damage was observed at the eaves, noted as 3C on the diagram.

3D. FINDING: Fungus damage was observed at the shelf, walls and cabinet under the sink in the hallway bathroom, noted as 3D on the diagram.

3E. FINDING: Fungus damage was observed at the subfloor under both bathrooms, noted as 3E on the diagram.

3F. FINDING: Fungus damage was observed at the rim joist, noted as 3F on the diagram.

3G. FINDING: There is a large amount of cellulose debris in earth contact in the substructure area. There is evidence of infestation by DRYWOOD TERMITES in this debris, noted as 3G on the diagram.

- 4C. FINDING: There is a faulty grade condition at the areas noted as 4C on the diagram.  
RECOMMENDATION: Owner to lower the soil in these areas and provide proper drainage away from the structure. (SECTION II ITEM)

- 4H. FINDING: A plumbing LEAK was observed at the water line, noted as 4H on the diagram.  
RECOMMENDATION: The OWNER should have a licensed plumber, or someone in this line of work, repair the leakage. Any guarantee desired should be secured from the party that actually performs the work. (SECTION II ITEM)

RECOMMENDATION: Tarp, seal and FUMIGATE with the lethal gas, Vikane. SECTION I ITEM.

RECOMMENDATION: MASK and/or remove all pellets that are accessible. (SECTION I ITEM)

RECOMMENDATION: REMOVE and REPLACE the damaged wood members. If possible, we will chisel or cut out damaged area and fill with either a plastic or wood filler. We will then sand and primer paint. SECTION I ITEM.

RECOMMENDATION: REMOVE and REPLACE the damaged wood members. SECTION I ITEM.

RECOMMENDATION: Remove cellulose debris of a size that can be raked from the substructure area. See additional findings for treatment for drywood termites. (SECTION I ITEM)
