WOOD DESTROYING PESTS AND ORGANISM INSPECTION REPORT

Building No. 442	Street Gosser Street	City Milpitas	ZIP 95035	Date of Inspection 11/12/2008	Number of Pages Page 1 of 6
----------------------------	--------------------------------	-------------------------	---------------------	---	---------------------------------------

HomeGuard Rpt #: **128303**

General Description: One story, single family wood framed residence with stucco and wood exterior.	Inspection Tag Posted Garage Other Tags Posted Able 9/10/08
---	--

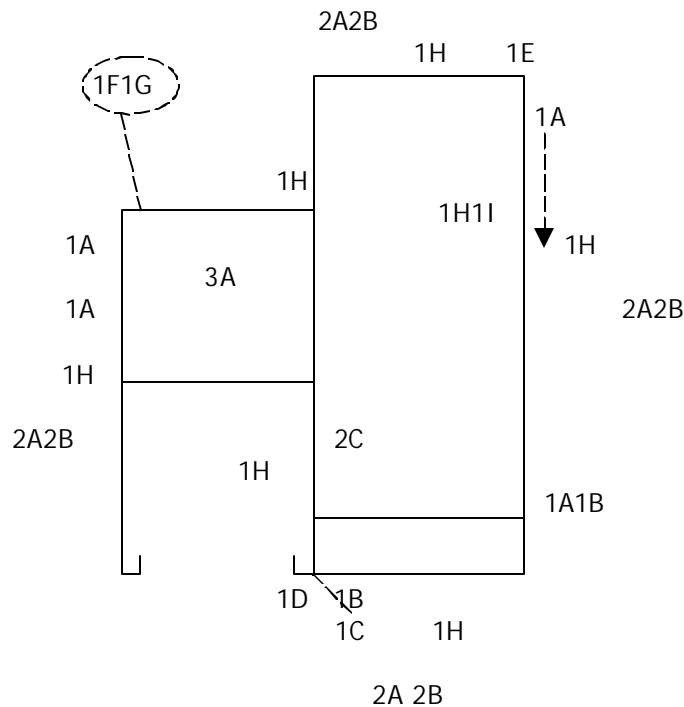
Key to Items on diagram: [1] Section 1 Items [2] Section 2 Items [3] Unknown Further Inspection Items

1A. FINDING: Fungus damage was noted to the rafters as indicated on the diagram.

1E. FINDING: Fungus damage was noted to the barge rafter as indicated on the diagram.

2A. FINDING: Minor stress cracks were noted in the exterior stucco as indicated on the diagram.

RECOMMENDATION: Remove and replace the damaged wood members to correct this condition. This bid includes replacement of the roof covering if disturbed by our repairs. The guarantees on the roof covering are limited to the areas where work was performed. It will be the owner's responsibility to reinstall the gutters upon completion of our roof repairs if necessary.

RECOMMENDATION: Remove and replace the damaged wood members to correct this condition. This bid includes replacement of the roof covering if disturbed by our repairs. The guarantees on the roof covering are limited to the areas where the work was performed. It will be the owners responsibility to reinstall the gutters upon completion of our roof repairs if necessary.

RECOMMENDATION: The owner is to seal these areas and maintain the exterior paint.
***** (SECTION 2 ITEM) *****
