Roof Inspection Report

442 Gosser Street, Milpitas, 95035

Ernest (Andy) Rodriguez
November 12, 2008
Report No. 128303

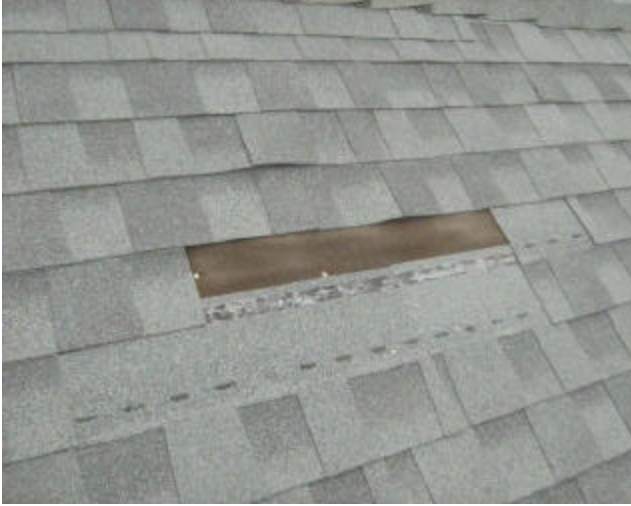
Picture 1

1. There are missing shingles in the field. (See Picture 1)
RECOMMENDATION:
Replace and/or repair all missing shingles in the field as needed.
2. The shingles are not fastened in accordance to industry standards. This condition may allow shingles to blow off during extreme weather conditions. Owner is advised to closely monitor the roof for missing shingles after windy conditions. (See Picture 2) (See Picture 3)
RECOMMENDATION:
Add additional fasteners to shingles where needed to help prevent shingle blow-off. It may not be possible to add additional fasteners where the shingles are sealed.

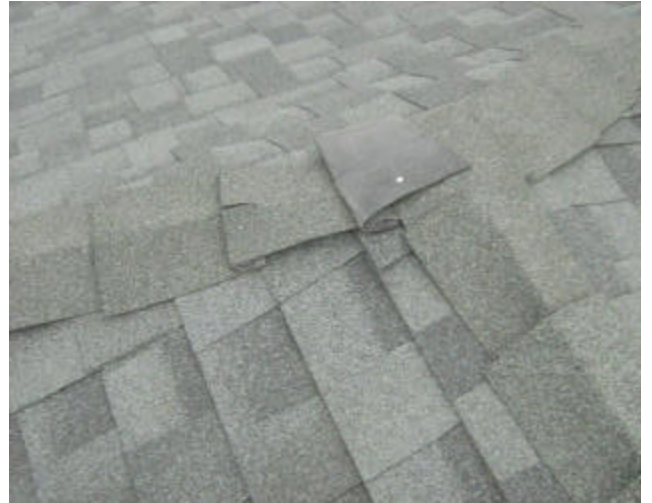
Picture 4

3. There are loose ridge caps. (See Picture 4)
RECOMMENDATION:
Repair and/or replace all loose ridge caps as needed.
4. We noted a back valley roof to wall that are not properly integrated into the roofing system. The water shedding ability of this area cannot be guaranteed. (See Picture 5)
RECOMMENDATION:
Properly integrate the back valley roof to wall into the roof system as needed to ensure a water impermeable condition.

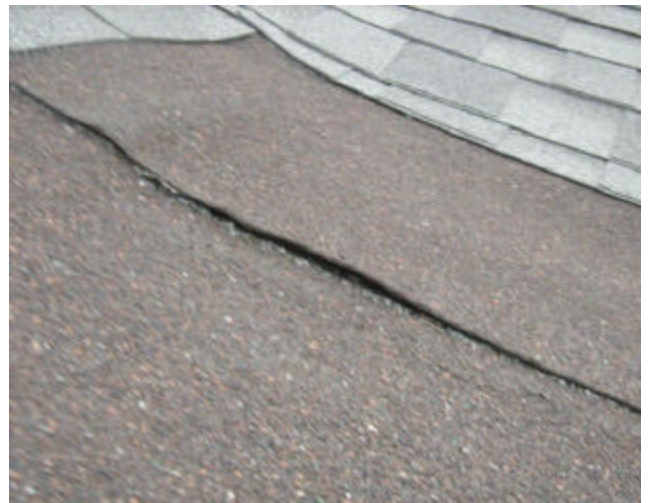
Picture 6

7. Regarding the back modified roof system. The seams on the modified bitumen roofing system do not have an adequate seal and may allow water entry into the structure. (See Picture 6)

Seal any seam on the modified bitumen that lacks proper seal.

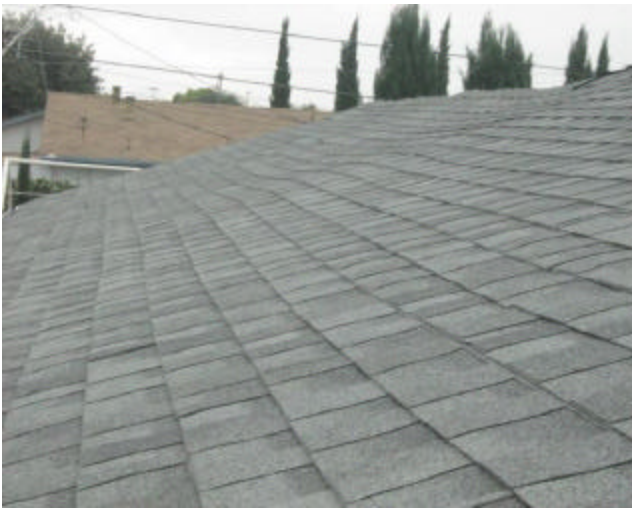
Picture 7

6. Areas of the roof structure are noted to be sagging. The roof structure should be monitored for further sagging. The owner is advised to contact a contractor or someone in this line of work to inspect this area and make any recommendations and/or repairs deemed necessary. (See Picture 7)

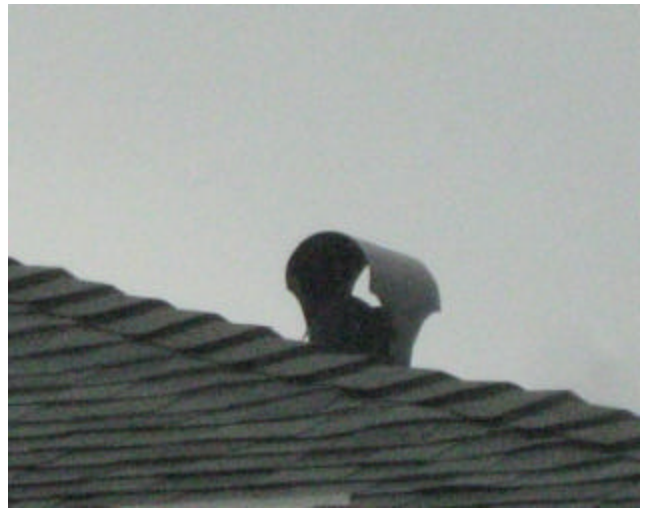
Picture 8

5. Homeguard feels that the flashing used at the vent is inappropriate and may leak under certain conditions. (See Picture 8)
RECOMMENDATION:
Cut down the vent flashing as needed to protect against wind driven rain.
