Property Inspection Report

442 Gosser Street, Milpitas, CA 95035

William Chase
November 12, 2008
Report No. 128303

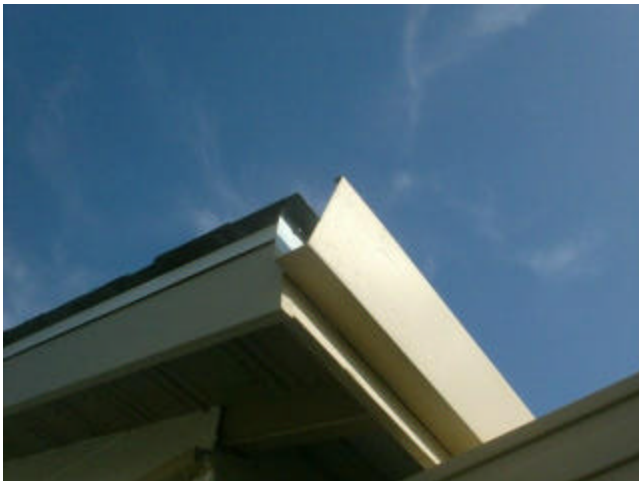
Picture 1

- ! 1. Repairs to the roofing are recommended. Damaged, loose or missing roofing material should be repaired or replaced as needed. All roof penetrations should be examined and sealed as necessary. For further evaluation of the condition of the roof we recommend you consult a licensed roofing contractor.
- ! 2. Damaged gutters at the front should be repaired or replaced as necessary. (See Picture 1)
- 3. The downspout(s) should discharge water at least five (5) feet from the house. Water should be encouraged to flow away from the building at the point of discharge. The installation of underground drainage were applicable may help to control surface drainage.
- ! 4. All deteriorated, damaged, missing or rusted out roof vent caps should be replaced.

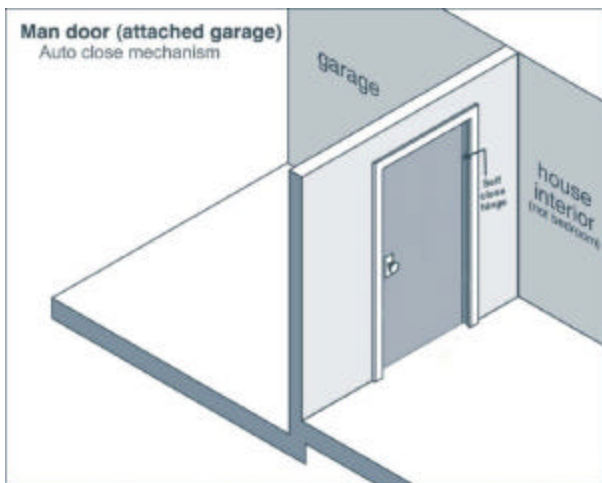
Illustration 6B

1. The main garage door requires adjustment/repairs to close or function properly.
- ! 2. The door between the garage and the interior of the house should be fitted with an automatic closer mechanism. This will reduce the potential of toxic automobile gases entering the house and serves as a fire break. (See Illustration 6B)

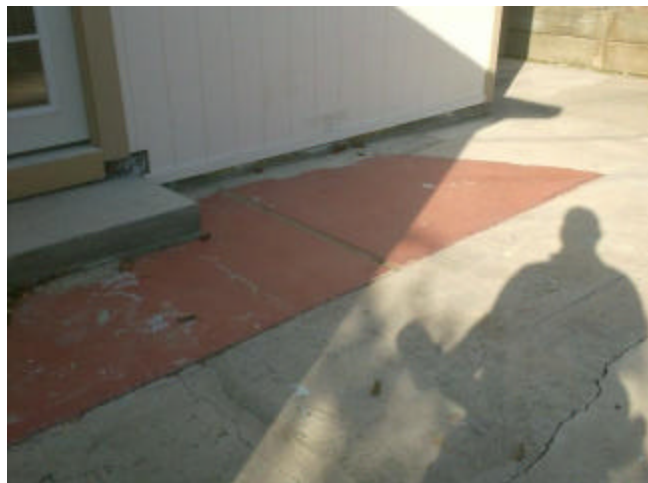
Picture 2

- 10 There is no fencing at the right side of the structure. We recommend all sections of missing fence be replaced.
- ! 11 The grading at the rear wall should be improved to promote the flow of water away from the structure. The ground should slope away from the structure to allow for adequate drainage. Ideally, at least 8 (eight) inches of clearance should be maintained between the soil levels and the top of the foundation walls. (See Picture 2)

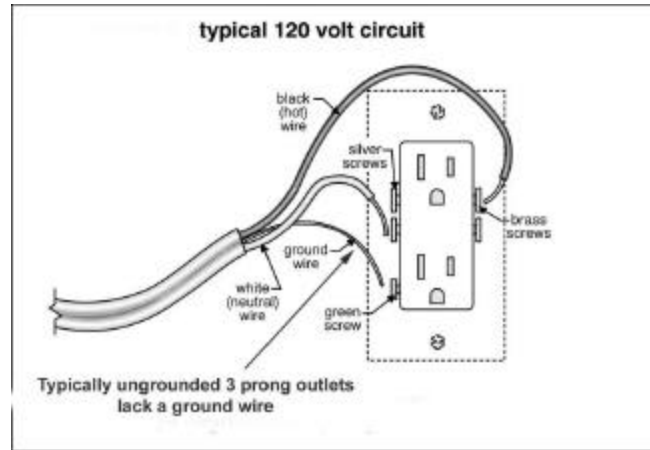
Illustration 100

- ! 2. Ungrounded 3-prong interior outlets at the rear study, dining room, living room and kitchen knook should be improved. A grounded cable or ground wire could be strung to these outlets, the outlet labeled as ungrounded or the original 2-prong receptacle could be reinstalled. If applicable, some electrical codes allow the installation of a ground fault circuit interrupter (GFCI) type receptacle where grounding is not provided. Based upon our inspection of a representative number of outlets, we recommend testing of every outlet. Repairs or rewiring are recommended at all deficient locations. For additional information we recommend a licensed electrician be consulted. (See Illustration 10O)

- ! 6. Ungrounded 3-prong interior outlets at the kitchen should be improved. A grounded cable or ground wire could be strung to these outlets, the outlet labeled as ungrounded or the original 2-prong receptacle could be reinstalled. If applicable, some electrical codes allow the installation of a ground fault circuit interrupter (GFCI) type receptacle where grounding is not provided. Based upon our inspection of a representative number of outlets, we recommend testing of every outlet. Repairs or rewiring are recommended at all deficient locations. For additional information we recommend a licensed electrician be consulted. (See Illustration 10O)

- ! 8. Ungrounded 3-prong interior outlets at the hall bathroom and master bathroom should be improved. A grounded cable or ground wire could be strung to these outlets, the outlet labeled as ungrounded or the original 2-prong receptacle could be reinstalled. If applicable, some electrical codes allow the installation of a ground fault circuit interrupter (GFCI) type receptacle where grounding is not provided. Based upon our inspection of a representative number of outlets, we recommend testing of every outlet. Repairs or rewiring are recommended at all deficient locations. For additional information we recommend a licensed electrician be consulted. (See Illustration 10O)

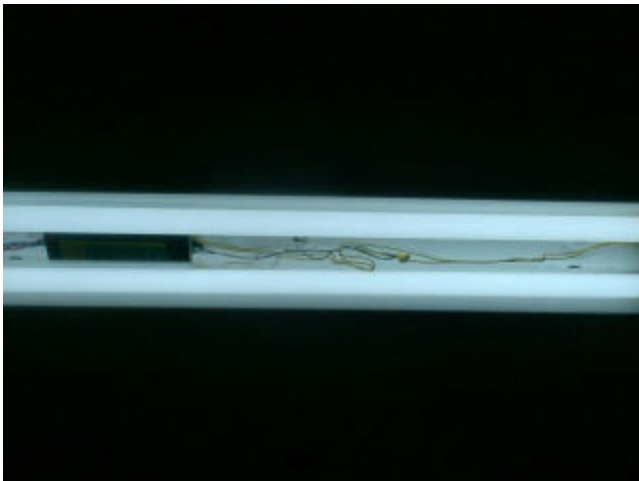
Picture 4

- 13 One or more of the main panel screws are missing or incorrect. We recommend proper blunt-end screws be installed.
- ! 14 Exposed electrical connections or open junction box(s) in the garage should be improved. All electrical connections should be made inside approved junction boxes fitted with cover plates. (See Picture 4)

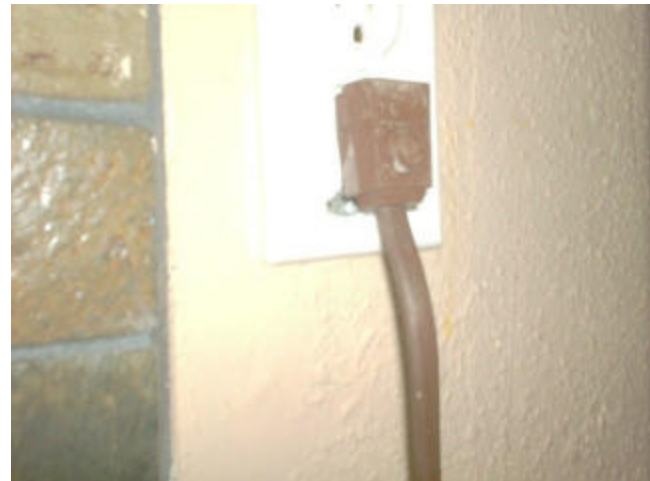
Picture 6

- ! 4. The missing outlet cover plates under the kitchen sink should be replaced.
- ! 5. The damaged/cracked outlet cover plates at the kitchen should be replaced. (See Picture 6)

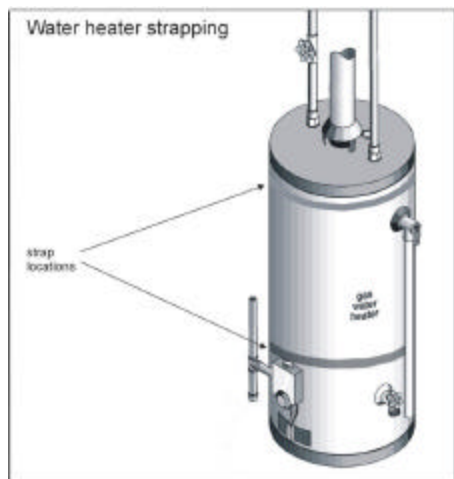
Illustration 9AE (Please note this diagram refers to two strap installations)

- ! 5. The water heater tank has been strapped in an improper manner and/or materials. We recommend the restraint be improved as per state codes. Specifically California state code is as follows.
