Roof Inspection Report

442 Gosser Street, Milpitas, 95035

Ernest (Andy) Rodriguez
November 12, 2008
Report No. 128303

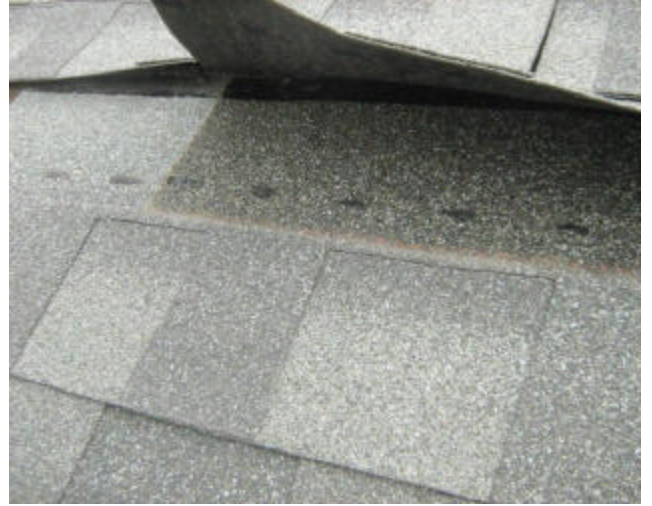
Picture 1

1. There are missing shingles in the field. (See Picture 1)
RECOMMENDATION:
Replace and/or repair all missing shingles in the field as needed.
2. The shingles are not fastened in accordance to industry standards. This condition may allow shingles to blow off during extreme weather conditions. Owner is advised to closely monitor the roof for missing shingles after windy conditions. (See Picture 2) (See Picture 3)
RECOMMENDATION:
Add additional fasteners to shingles where needed to help prevent shingle blow-off. It may not be possible to add additional fasteners where the shingles are sealed.
